September 26, 2022

July 27, 2022  
File: 121624431

**Reference: Results of Stage 1 Work Scope, Geotechnical Slope Stability Assessment,  
30 Flats Road, CBS, NL**

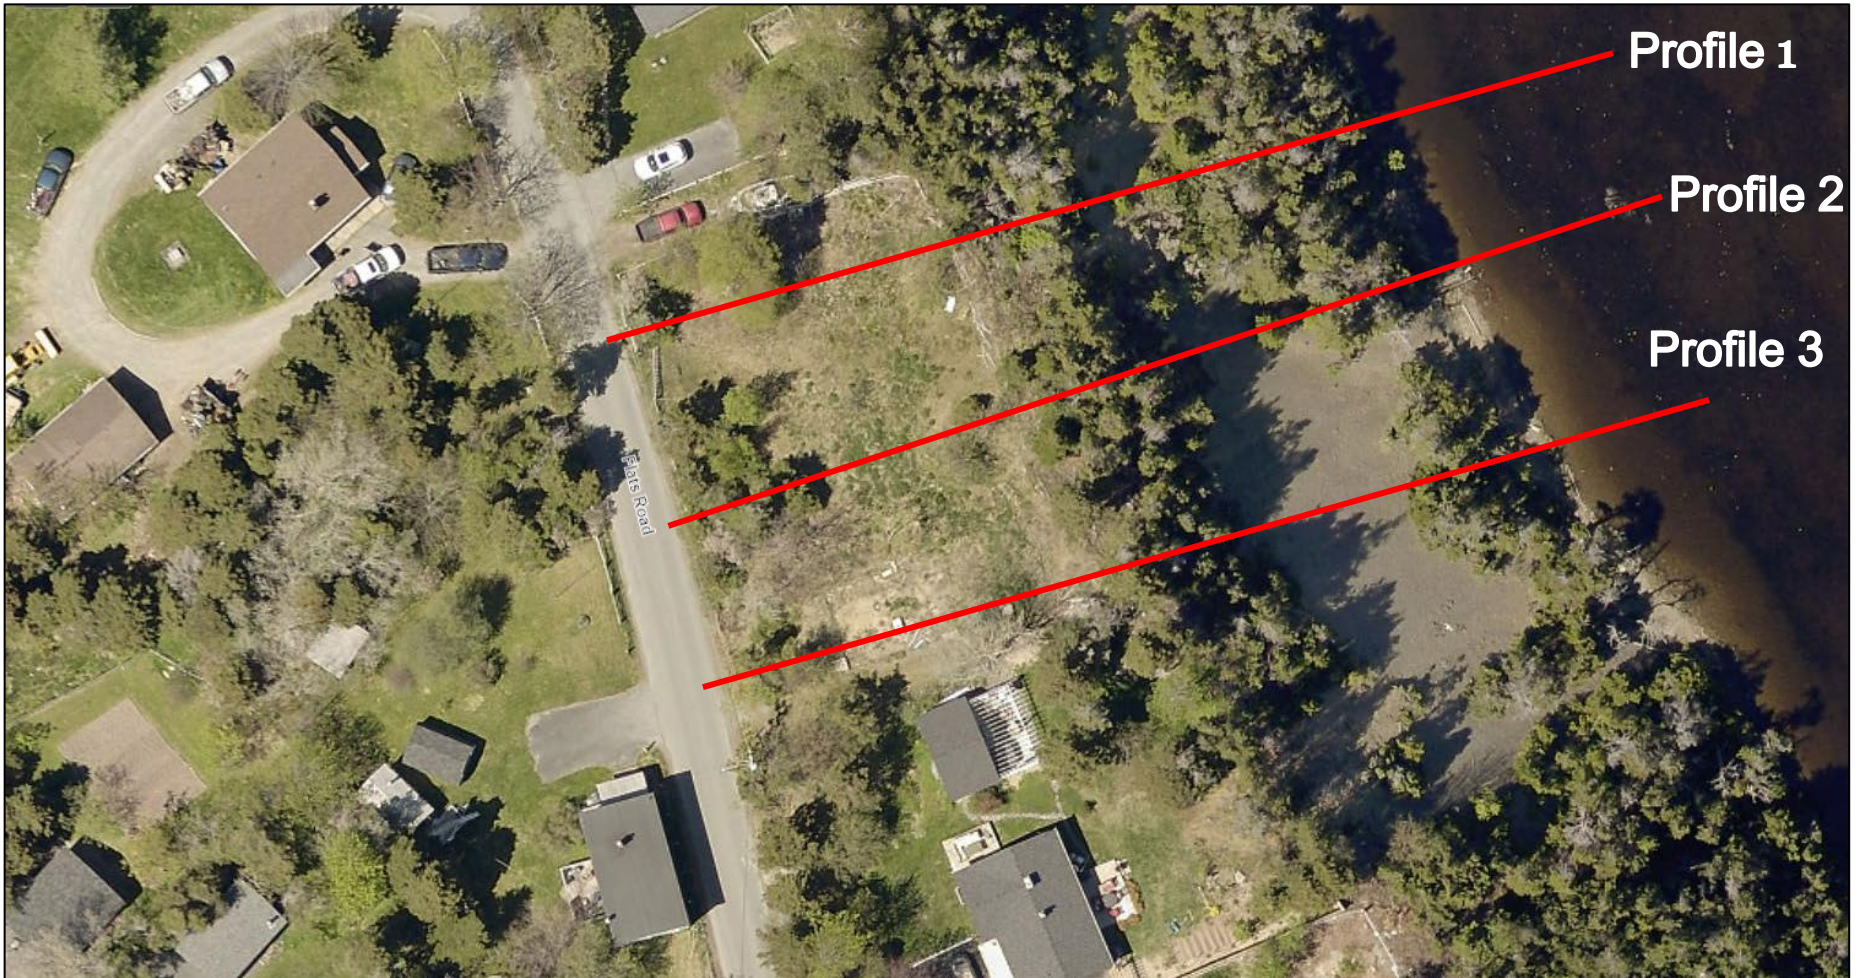
FIGURE 1  
SITE PLAN

As a visual aid, Figure 1 is attached and presents an overhead view of the site with profiles. Figure 2 shows the profile based on the Lidar data provided by the Town. The main slope has a height of approximately 26 m with a relatively consistent angle of about 1.4H:1V and localized areas as steep as 0.7H:1V, which classifies as moderately steep to steep. For this discussion, the slope was divided into three areas, as shown in Figure 1:

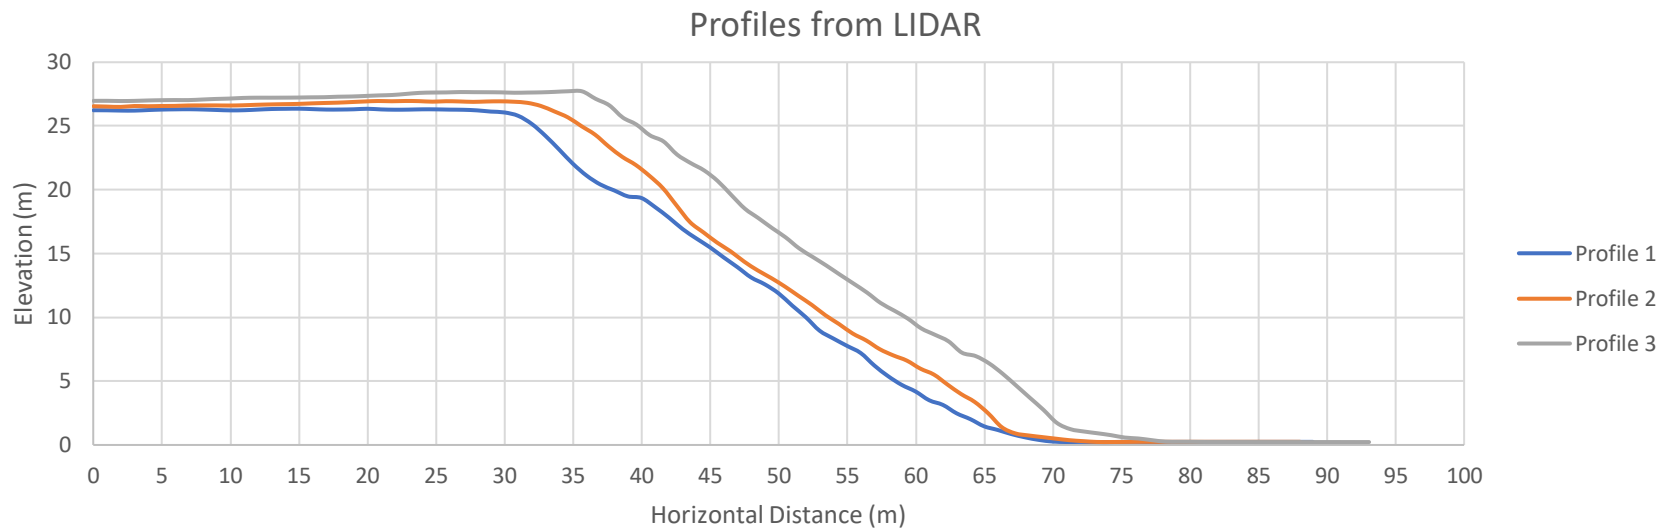
**FIGURE 2**  
**PROFILES FROM LIDAR**

Based on the Lidar data, an average slope of 35 degrees is observed for the sloping ground, which is at or close to the angle of repose of the overburden soils and weathered bedrock scree as observed in the site. In general practices, the required factor of safety of a sloping ground is considered 1.5 for long-term

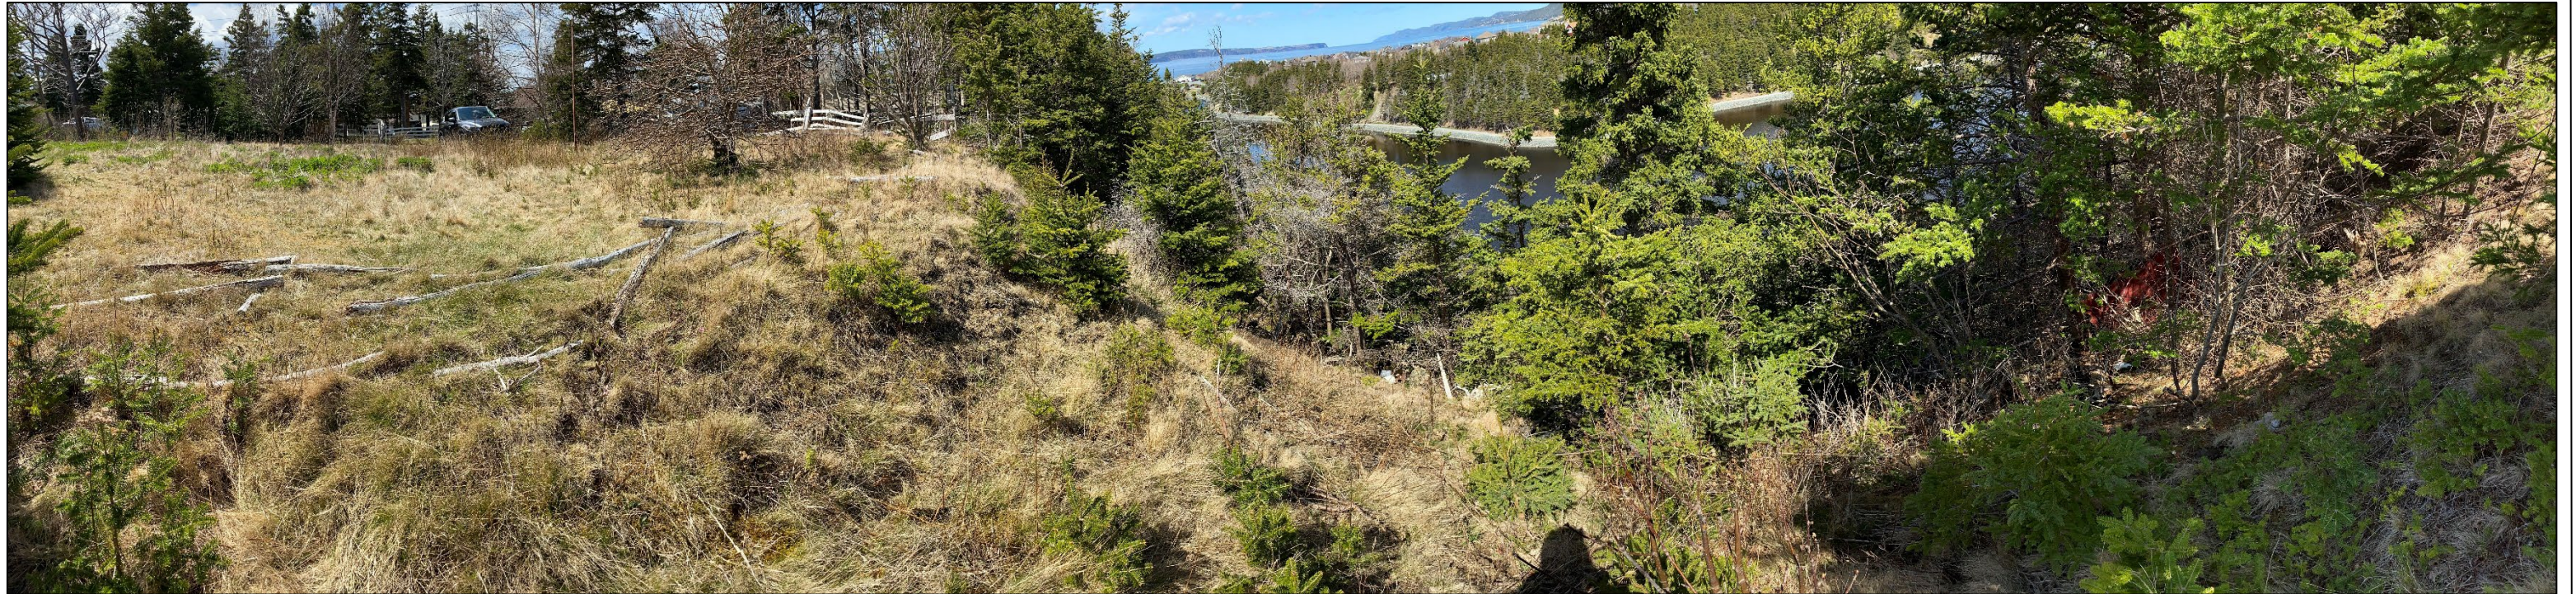
- Area 1 included the upper slope with mature trees (Site Photograph 1). Some features (materials, debris, etc.) suggested this part of the slope may have been constructed with fill to increase the usable space at the top of the slope. Some of the older trees near the top of the slope had fallen over at different angles (Site Photograph 2).

**SITE PHOTOGRAPH 1**  
 PANORAMIC VIEW OF THE TOP OF THE SLOPE

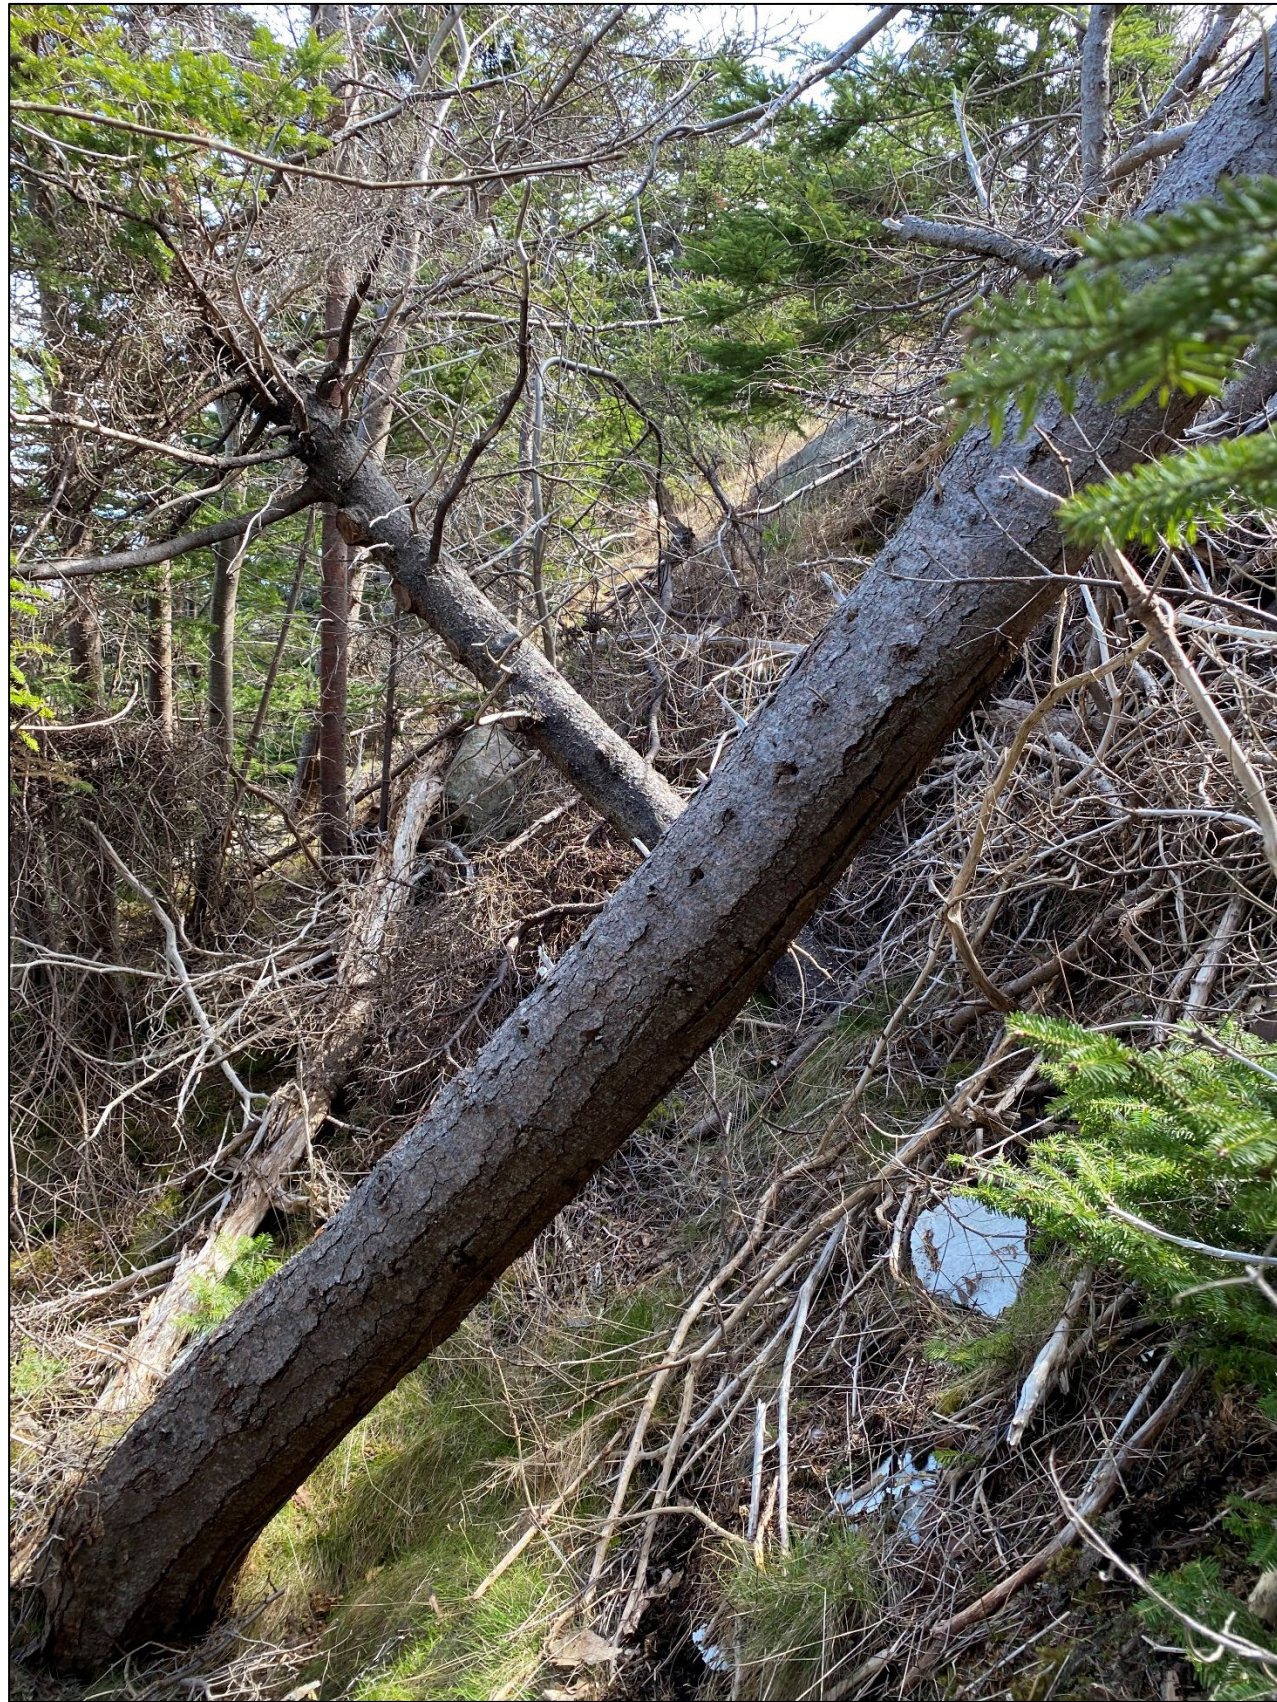
**SITE PHOTOGRAPH 2**  
SHOWING LEANING TREES NEAR TOP OF SLOPE

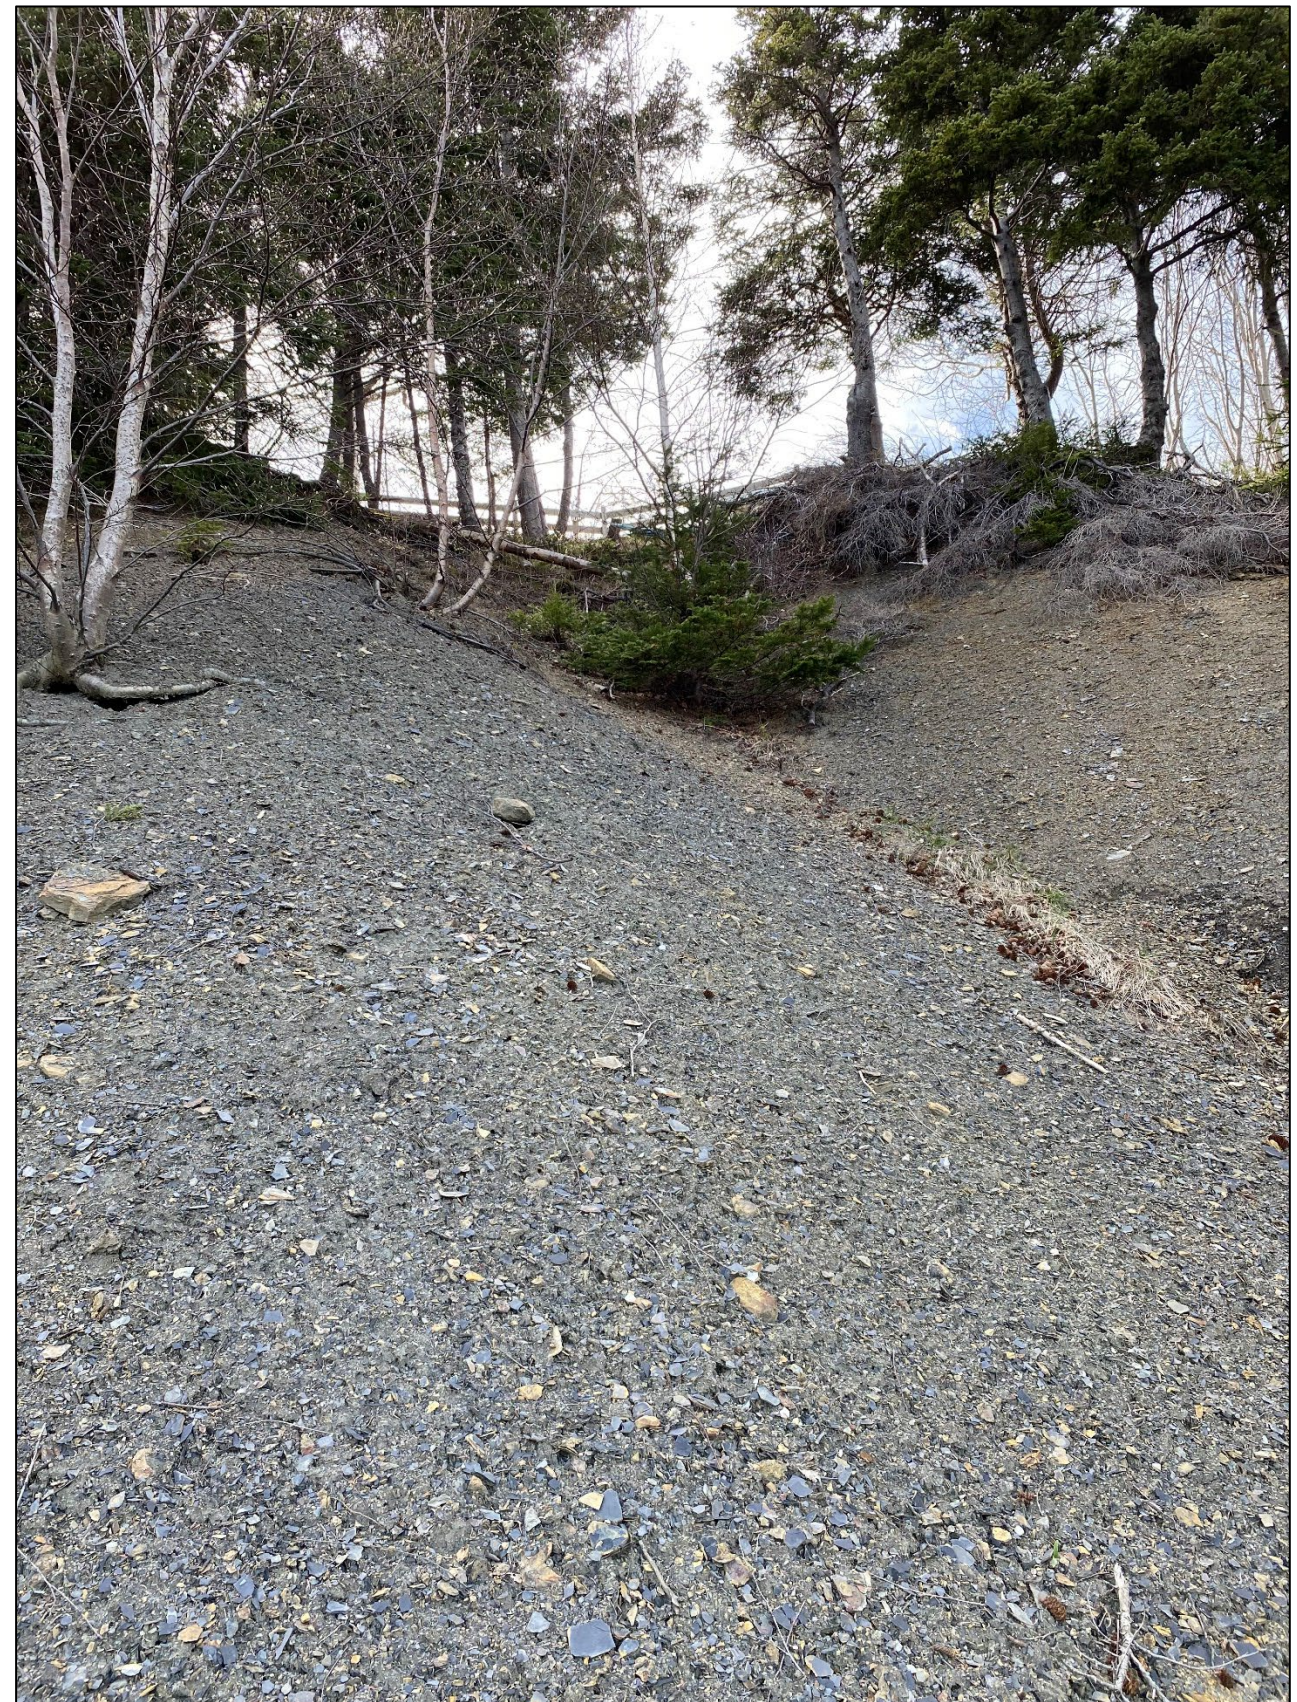
- Area 2 included the unvegetated section mid-slope with exposed shale clasts and scree (Site Photographs 3 and 4). Small shale outcrops were seen in a few places (Site Photograph 5). Some small trees were observed growing vertically in this area. The scree slope was unconsolidated and showed signs of continual weathering and mass wasting.

**SITE PHOTOGRAPH 3**  
SHOWING SHALE CLASTS AND SCREE SLOPE TO THE NORTH.

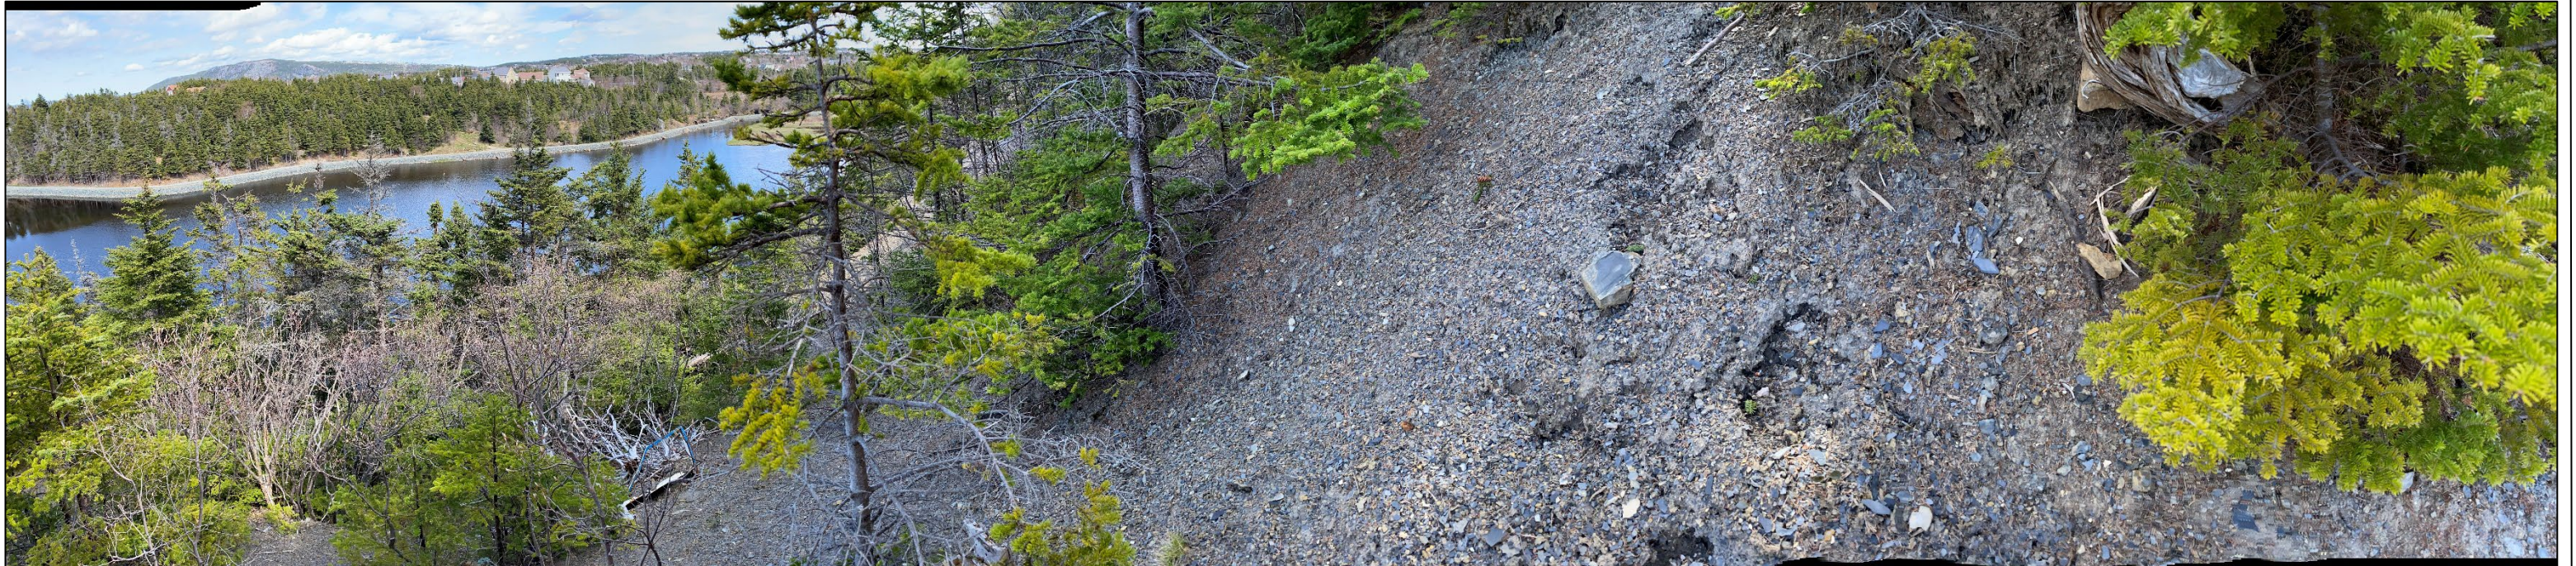
**SITE PHOTOGRAPH 4**  
 PANORAMIC VIEW OF MID-SLOPE

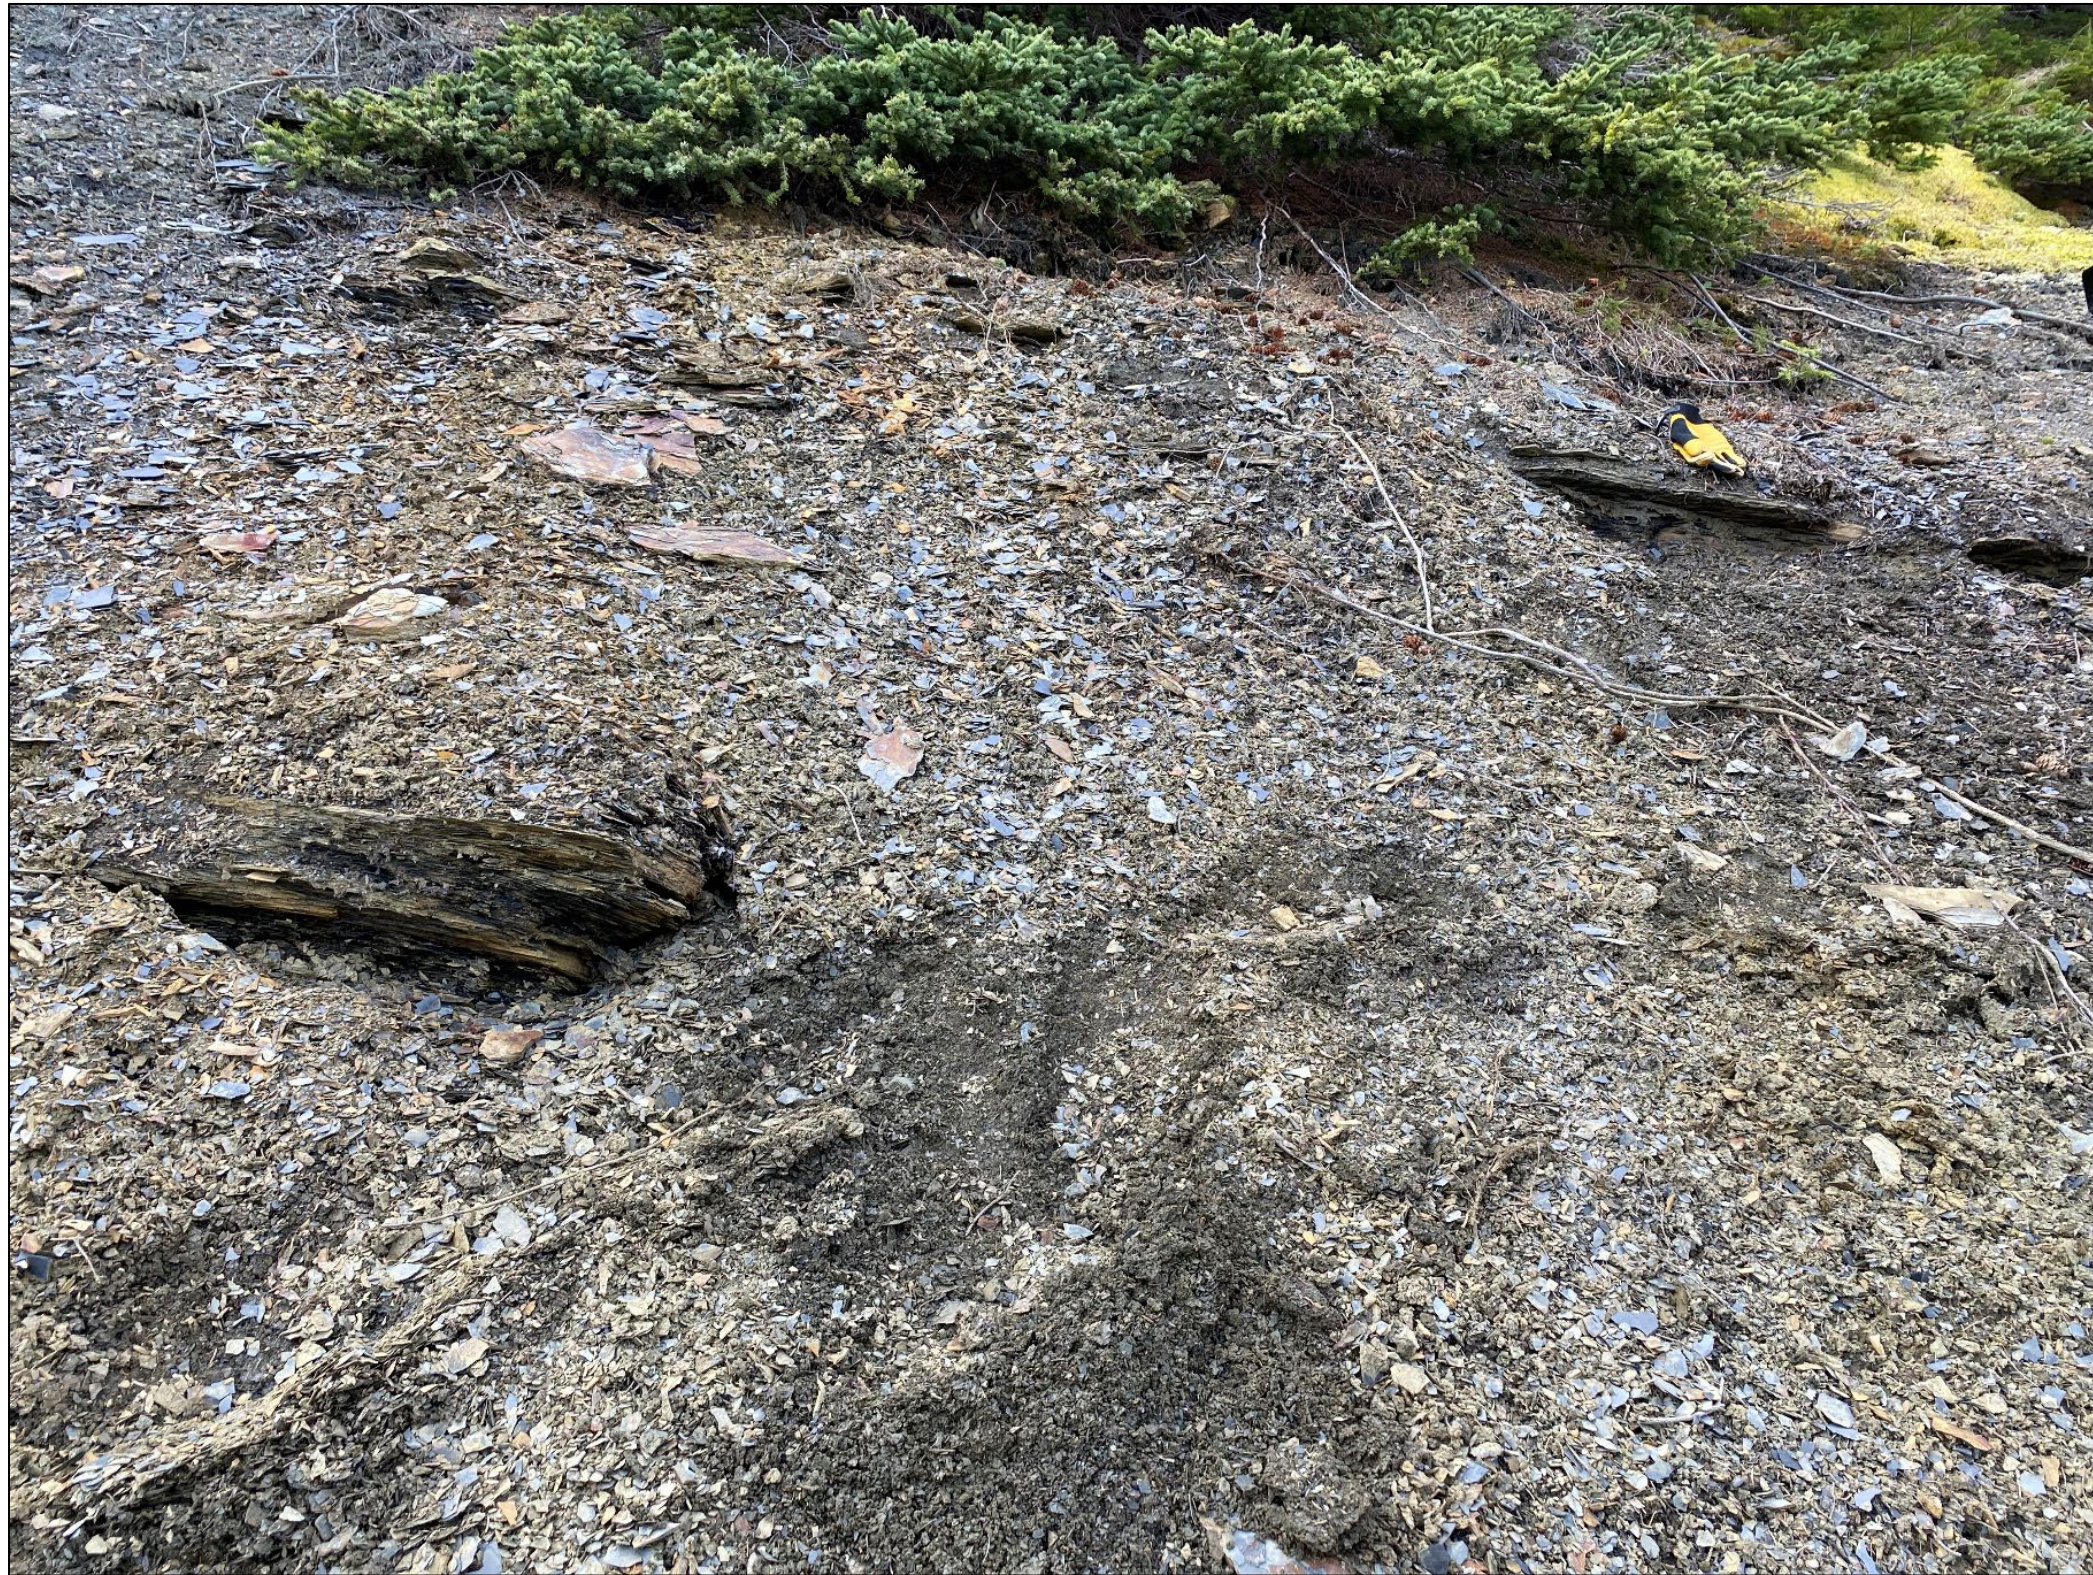
**SITE PHOTOGRAPH 5**  
 SHOWING SHALE CLASTS AND SCREE SLOPE WITH BEDROCK OUTCROPS.  
 TAPE MEASURE SHOWN FOR SCALE.

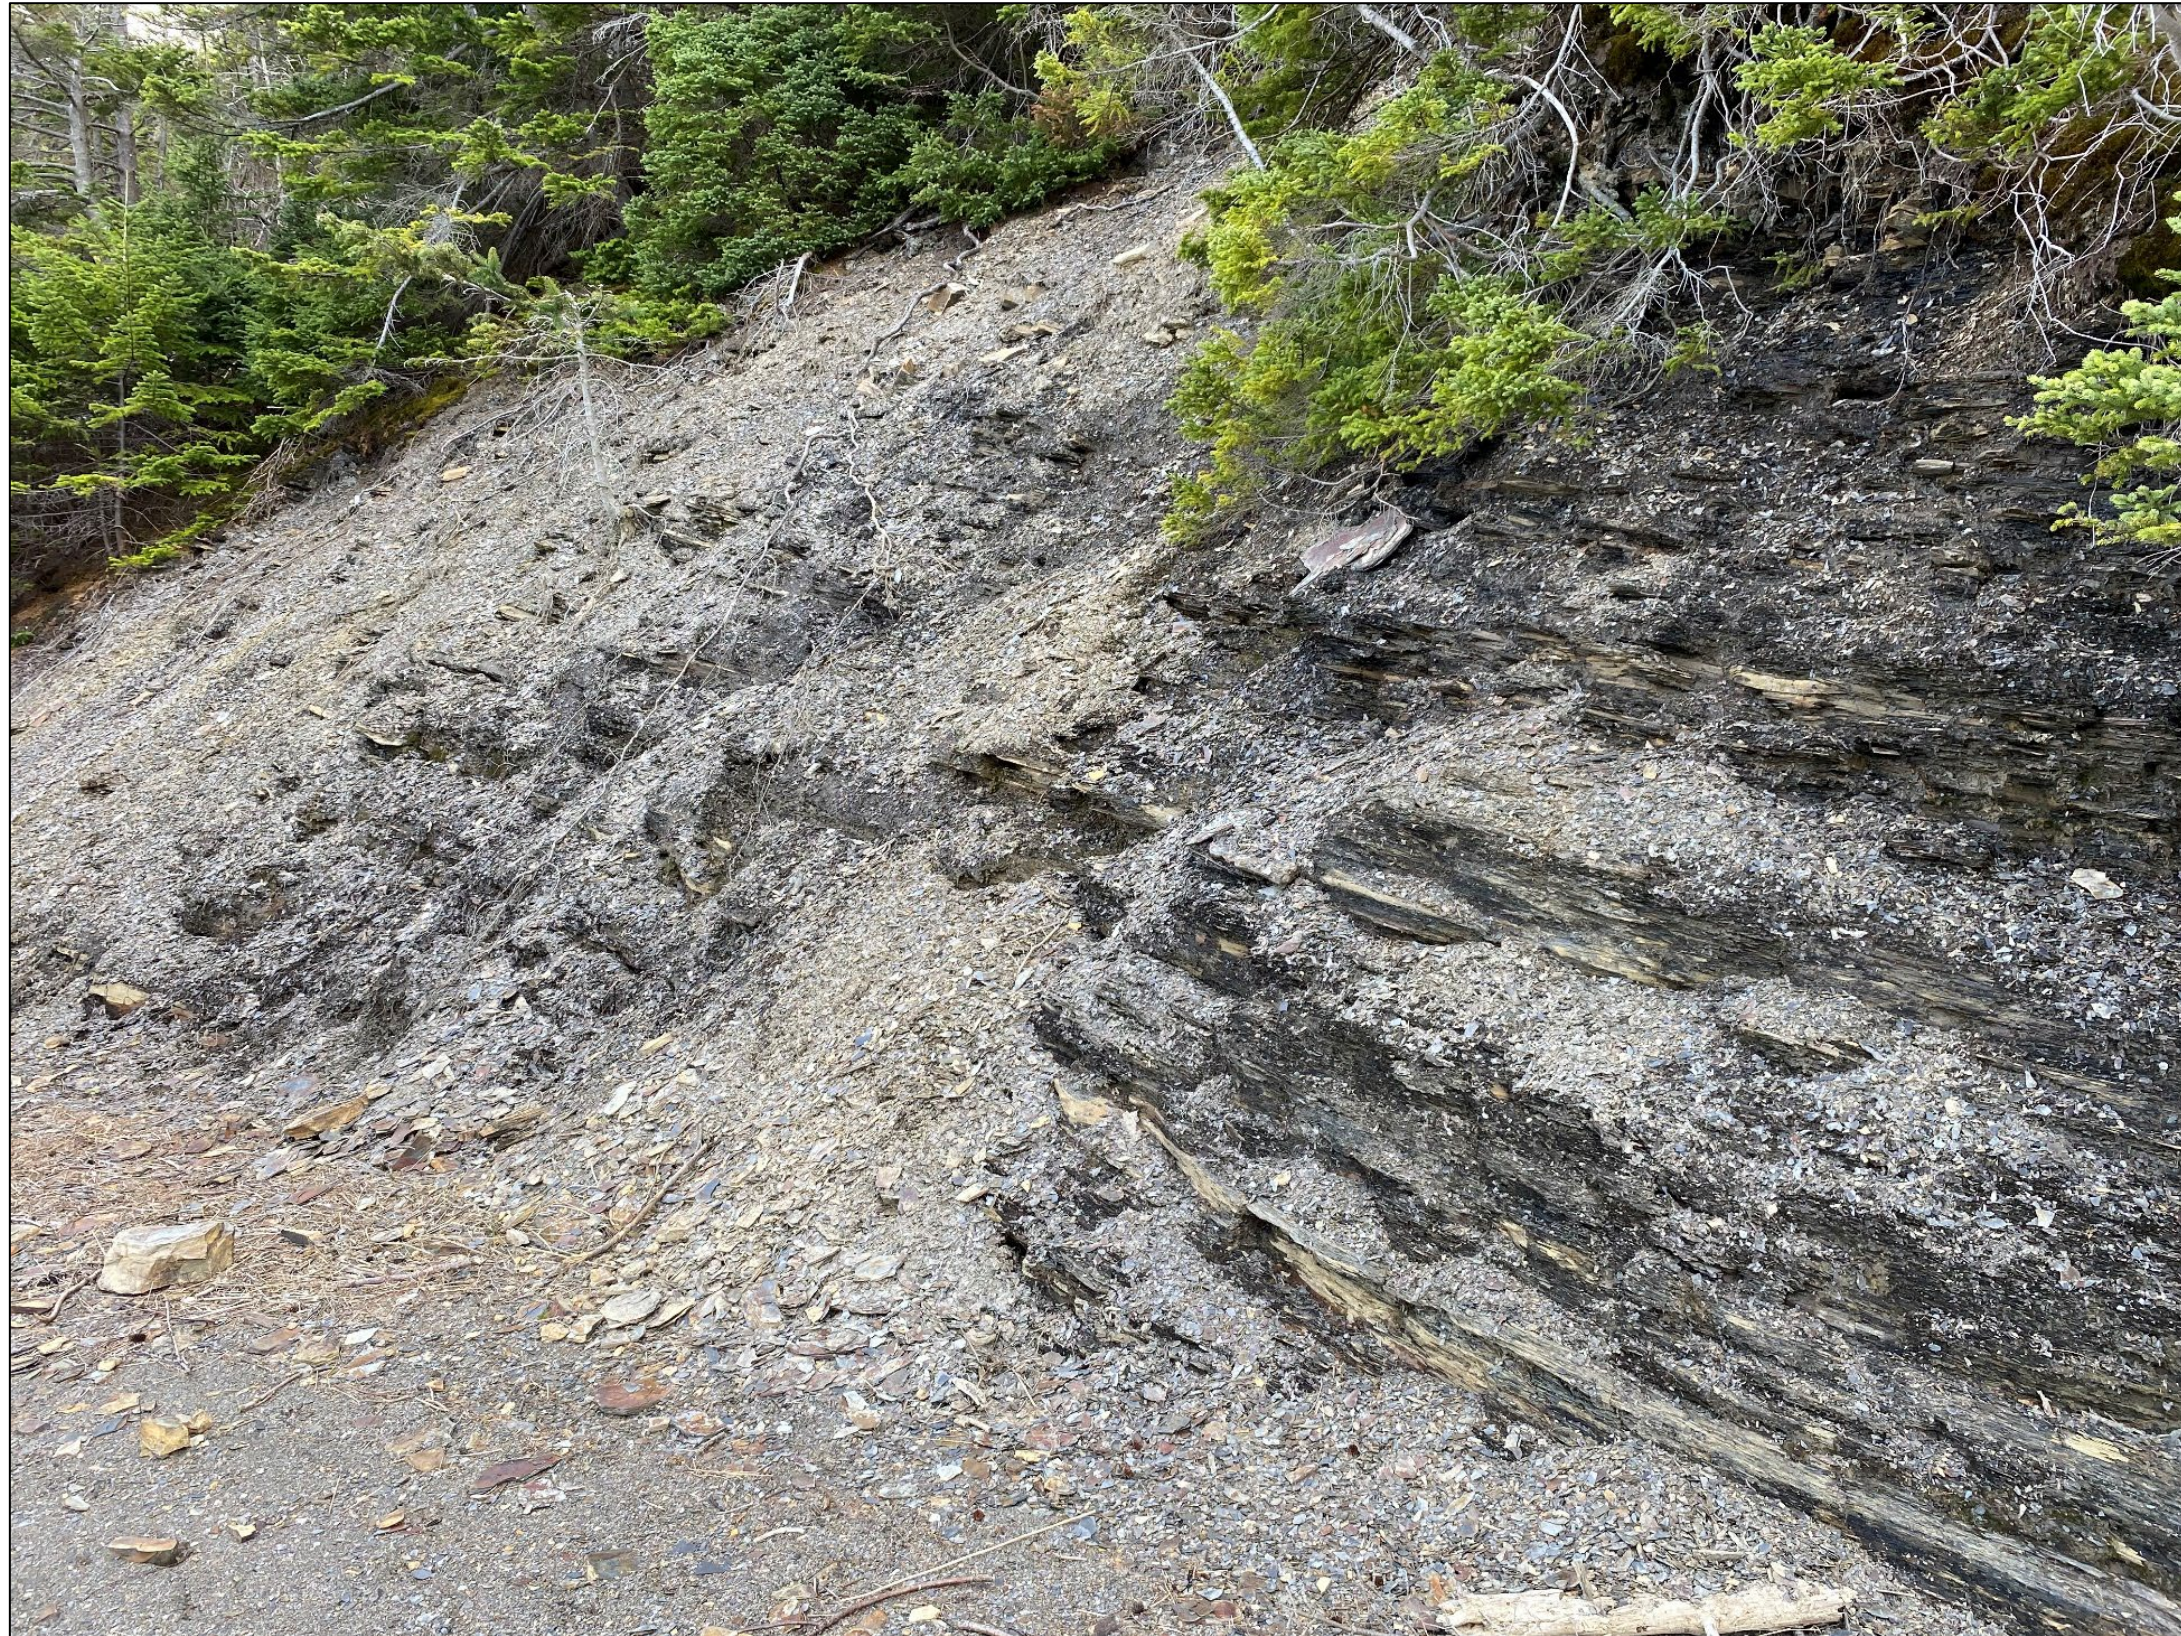
- Area 3 included the lower slope and toe (Site Photographs 6 to 8). The lower slope area was less steep (1H to 4H:1V) and contained mature trees. The scree was observed to be accumulating above the older trees below the scree slopes. Some of the trees in this area were observed to be at different angles, but most were vertical. The toe of the slope had a section of near vertical exposed shale bedrock outcrops (Site Photographs 6). The bedding angle of these outcrops matched the orientation of the smaller outcrops observed in Area 2. The toe of the slope formed the shoreline of Manuels River, with shale clasts forming the riverbed.

**SITE PHOTOGRAPH 6**  
SHOWING BEDROCK OUTCROP AT TOE OF SLOPE

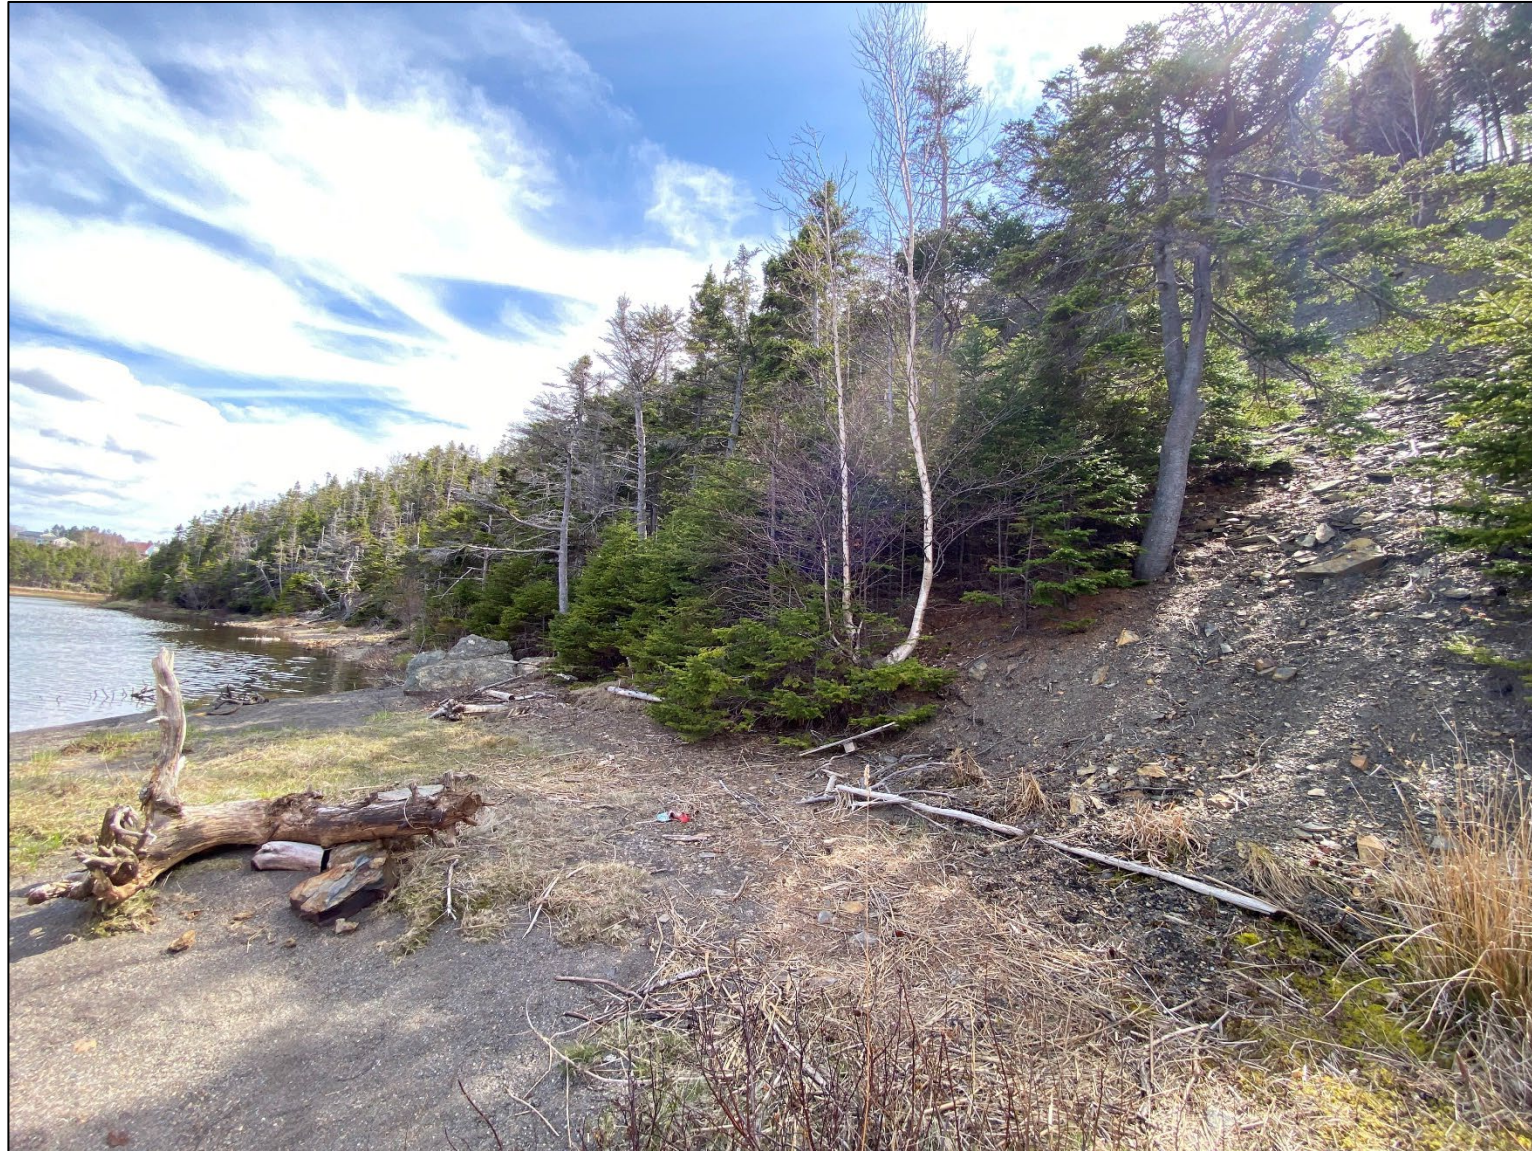
**SITE PHOTOGRAPH 7**  
SHOWING TOE OF SLOPE

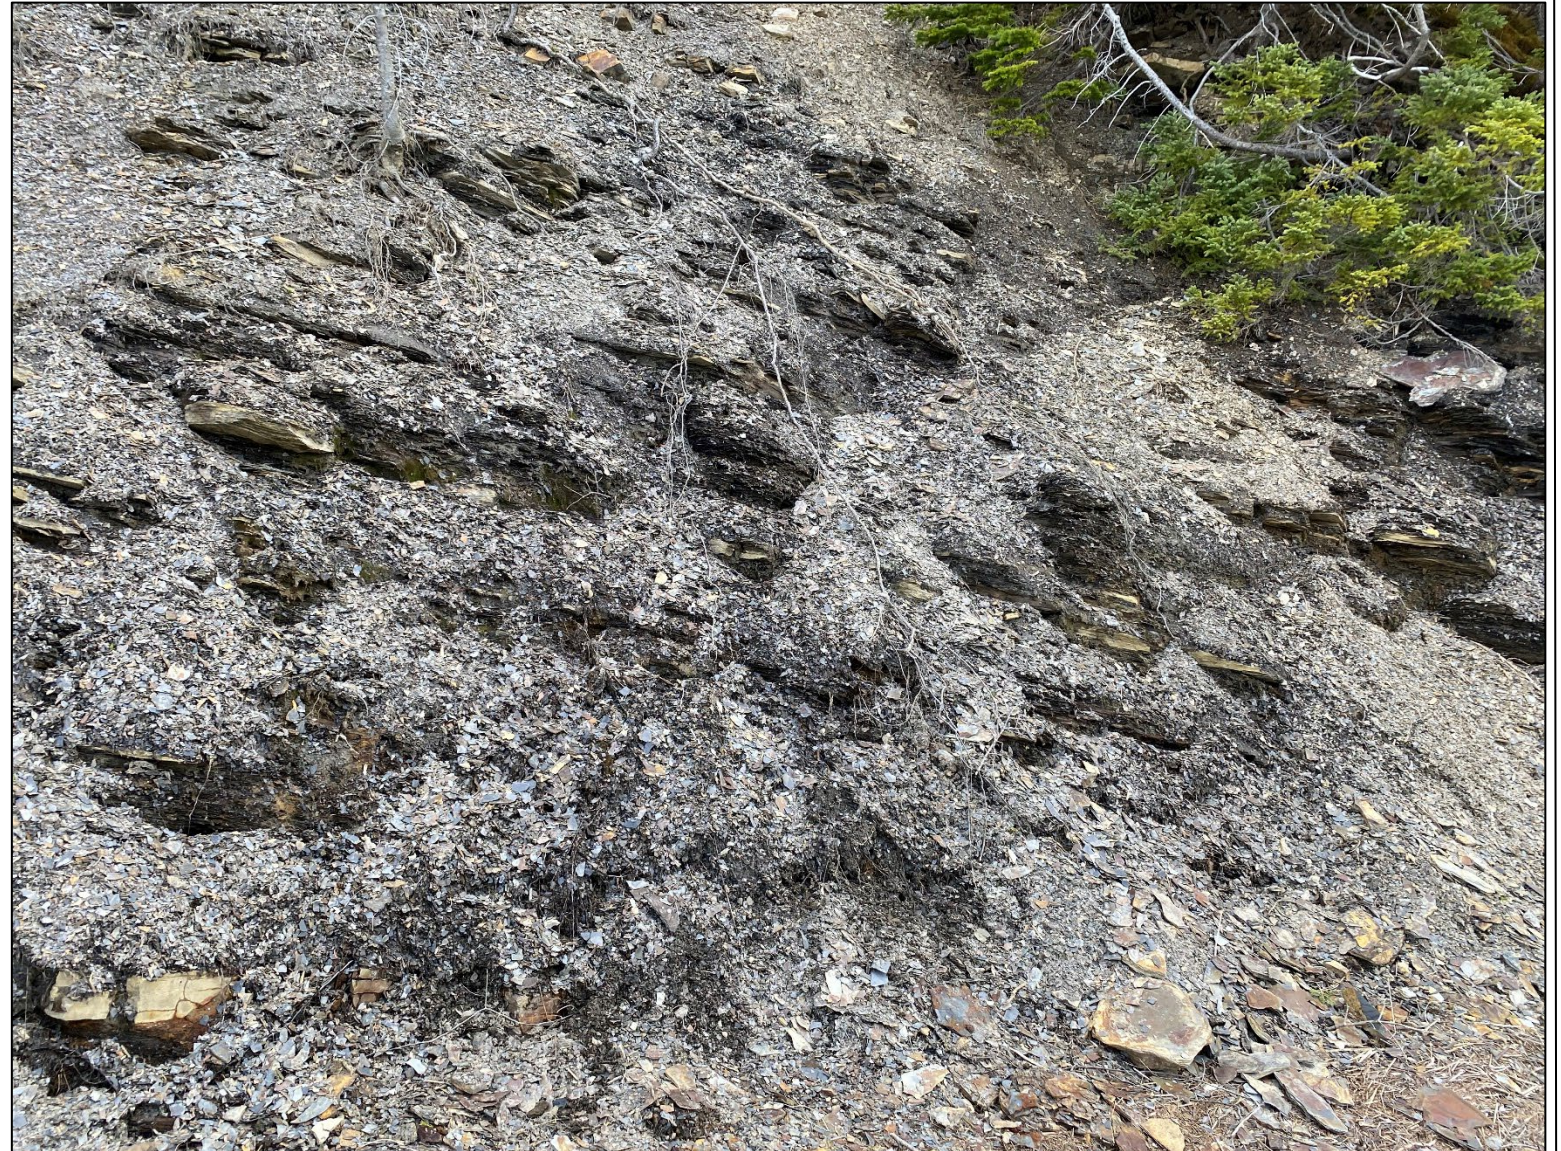
**SITE PHOTOGRAPH 8**  
SHOWING BEDROCK OUTCROP AT TOE OF SLOPE
